## Windstorm Mitigation Report (OIR-B1-1802)

Sunshine Villas Homeowners Association, Inc.

Bldg D, 21150 Gertrude Ave, Units 1-6

As of 10/26/2023 | FPAT File# MIT2321009

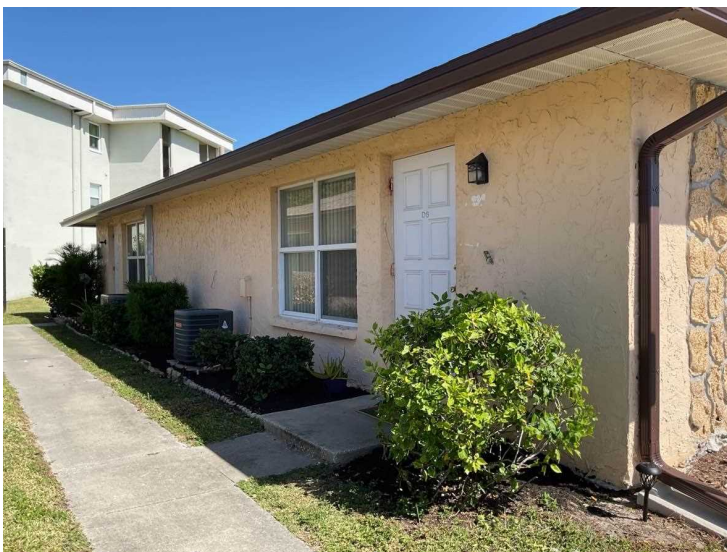
Exterior Elevation

- 4. Roof to Wall Attachment:** **Toe Nails**  
Comments: Inspection verified embedded straps fastened with less than three nails.
- 5. Roof Geometry:** **Hip Roof**  
Comments: Inspection verified a hip roof shape.

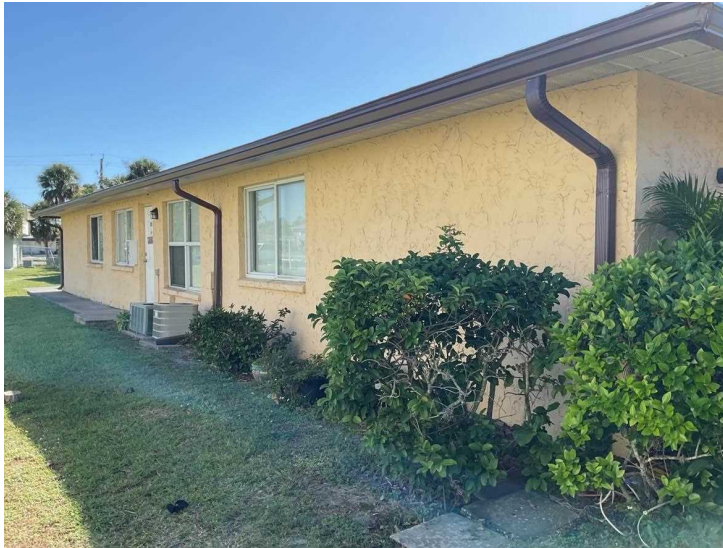
Roof Permit Information

- 2. Roof Covering:** **FBC Equivalent**  
Comments: The roof covering was replaced in 2022. The roof permit was confirmed and the permit number is 20221259650. This roof was verified as meeting the building code requirements outlined on the mitigation affidavit.

**Job Description:**  
Bldg D: Remove existing roof, re-nail deck as per FBC and install self-adhering Resisto underlayment, install new shingle.

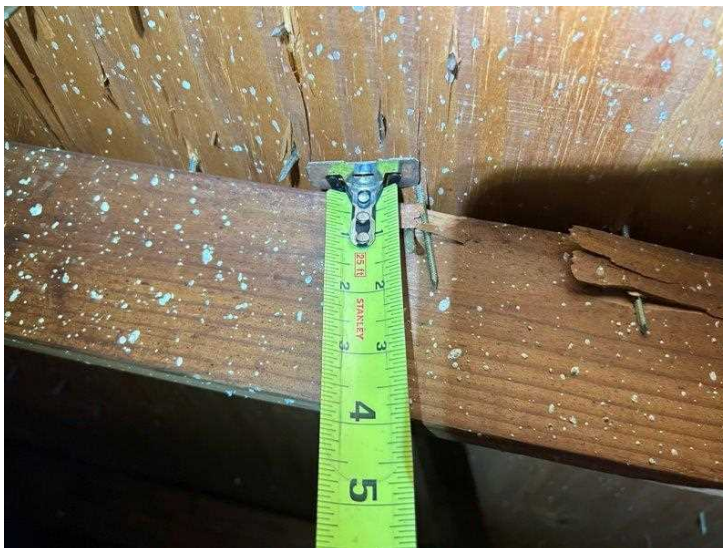
Roof Construction

- 3. Roof Deck Attachment:** **Level C**  
Comments: Inspection verified 1/2" plywood roof deck attached with 8d nails at a minimum 6" on the edge & 6" in the field.

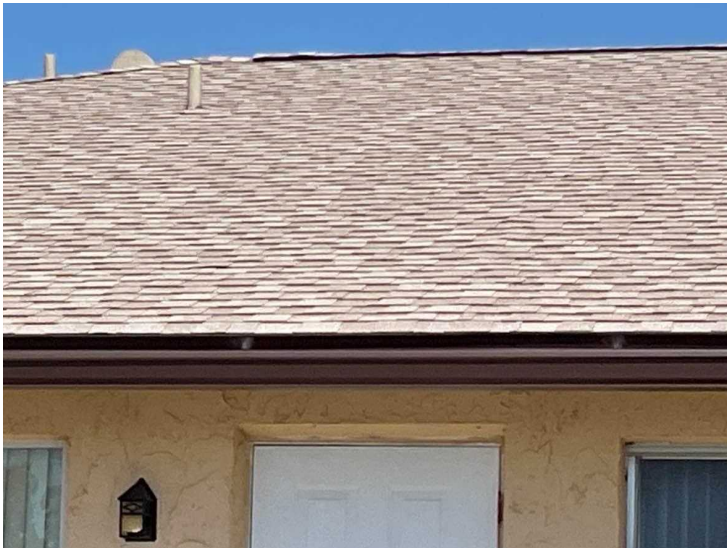
Roof Construction

- 6. SWR:** **Yes**  
Comments: SWR was verified at time of inspection. The Secondary Water Resistance verified is a self-adhering peel and stick.
- 7. Opening Protection:** **None or Some Glazed Openings**  
Comments: No opening protection verified at the time of inspection.
