Windstorm Mitigation Report (OIR-B1-1802)

Sunshine Villas Homeowners Association, Inc.

Bldg M, 21150 Gertrude Ave, Units 1-4

As of 10/26/2023 | FPAT File# MIT2321009

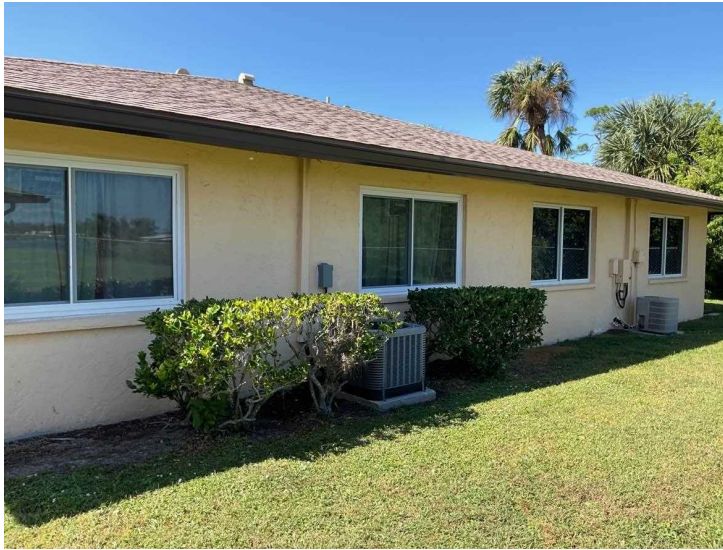
Roof Permit Information

Permit 20221259896:
Residential Roofing
Record Status: Closed

Job Description: BLDG M: Remove existing roof, re-nail deck as per FBC and install self-adhering Resisto underlayment, install new shingle.	Owner: SUNSHINE VILLAS HOMEOWNERS ASSOC INC * PO BOX 494016 PORT CHARLOTTE FL 33949
-------------------------------------------------------------------------------------------------------------------------------------------------------	-----------------------------------------------------------------------------------------------------

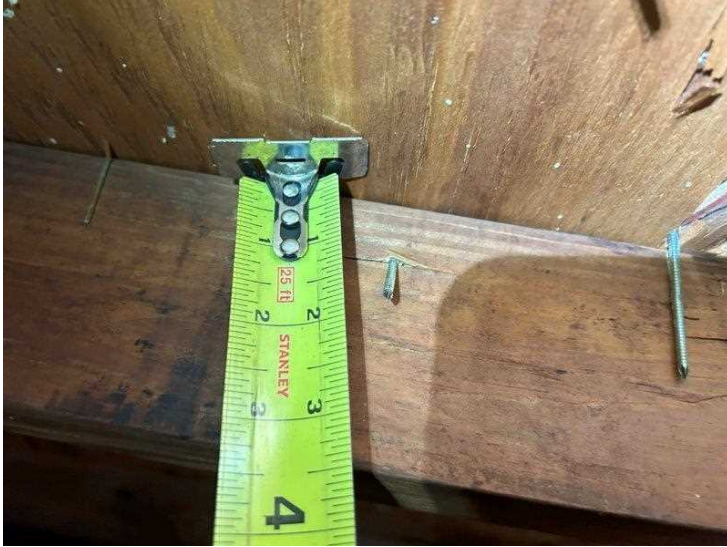
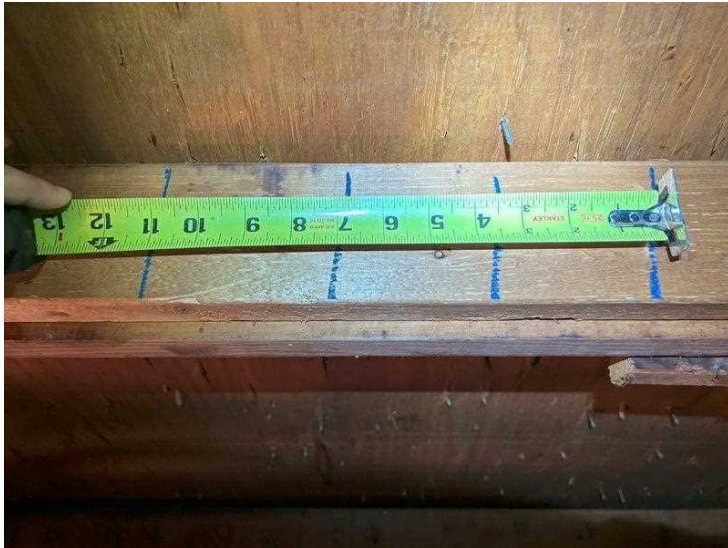
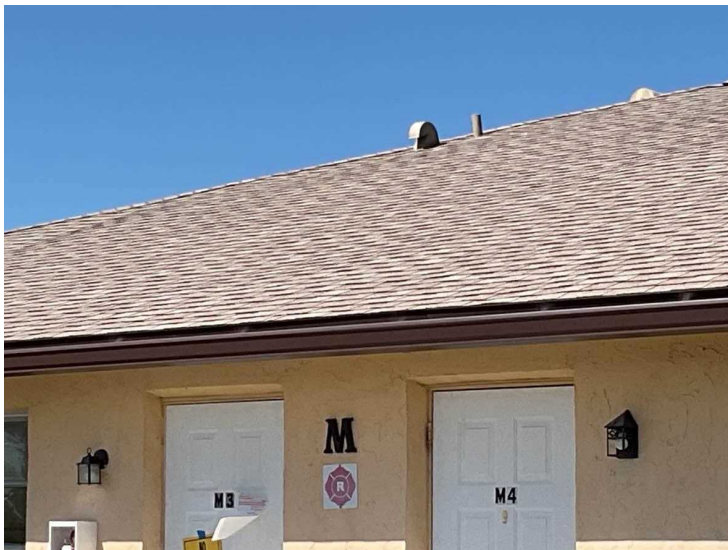
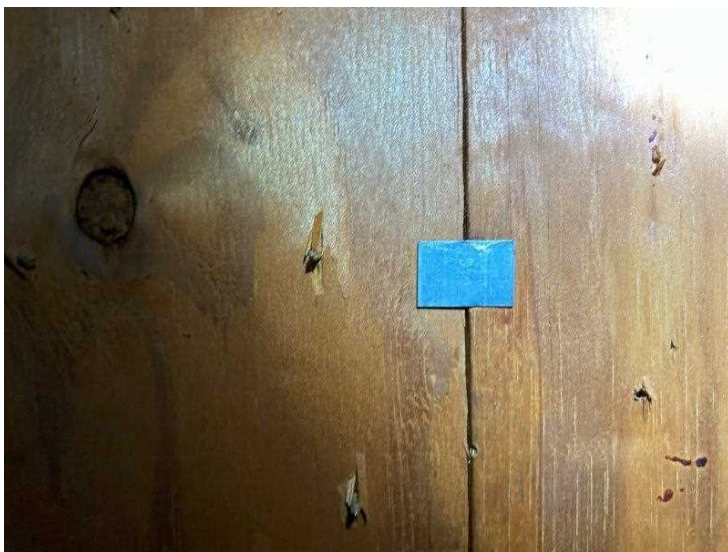
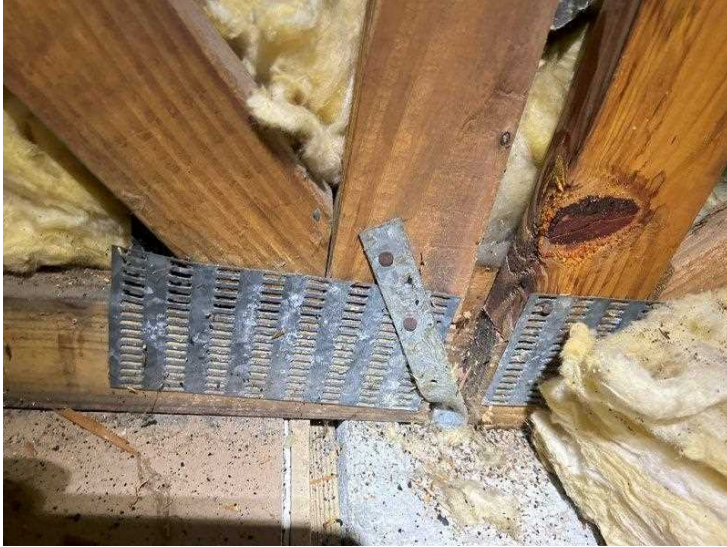
Roof Construction

- 3. Roof Deck Attachment:** **Level C**
Comments: Inspection verified 1/2" plywood roof deck attached with 8d nails at a minimum 6" on the edge & 6" in the field.

- 4. Roof to Wall Attachment:** **Toe Nails**
Comments: Inspection verified embedded straps fastened with less than three nails.
- 5. Roof Geometry:** **Hip Roof**
Comments: Inspection verified a hip roof shape.

- 6. SWR:** **Yes**
Comments: SWR was verified at time of inspection. The Secondary Water Resistance verified is a self-adhering peel and stick.
- 7. Opening Protection:** **None or Some Glazed Openings**
Comments: No opening protection verified at the time of inspection.
