Windstorm Mitigation Report (OIR-B1-1802)

Sunshine Villas Homeowners Association, Inc.

Bldg K, 21150 Gertrude Ave, Units 1-4

As of 10/26/2023 | FPAT File# MIT2321009

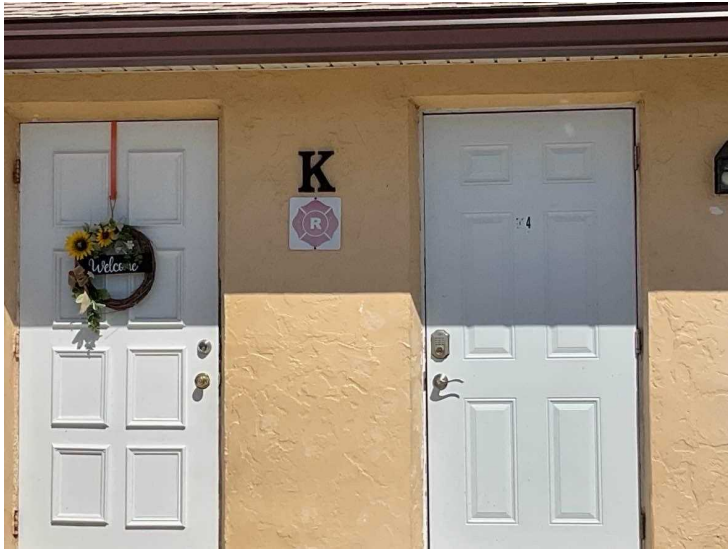
Exterior Elevation

- 4. Roof to Wall Attachment:** **Toe Nails**
Comments: Inspection verified embedded straps fastened with less than three nails.
- 5. Roof Geometry:** **Hip Roof**
Comments: Inspection verified a hip roof shape.

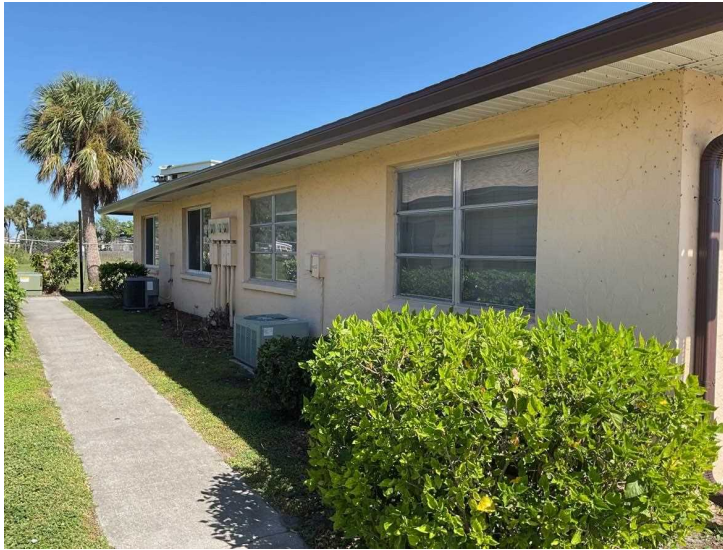
Roof Permit
Information

Permit 20221259662:
Residential Roofing
Record Status: Closed

Job Description:
BLDG K: Remove existing roof, re-nail deck as per FBC and install self-adhering Resisto underlayment, install new shingle.

- 2. Roof Covering:** **FBC Equivalent**
Comments: The roof covering was replaced in 2022. The roof permit was confirmed and the permit number is 20221259662. This roof was verified as meeting the building code requirements outlined on the mitigation affidavit.

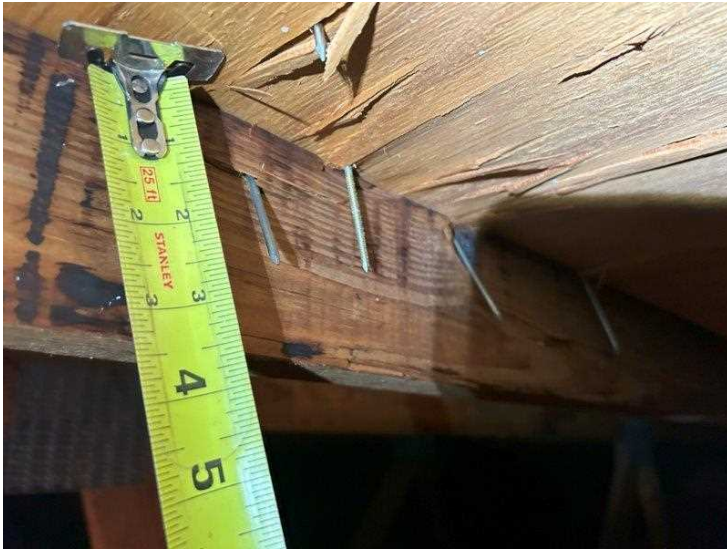
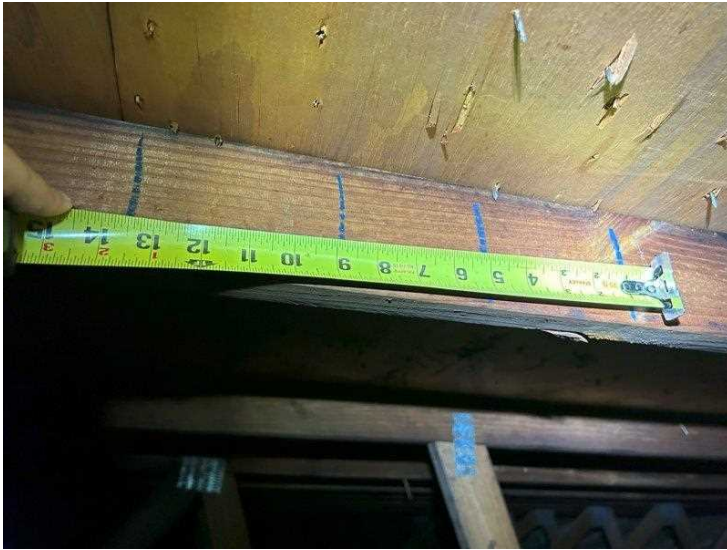
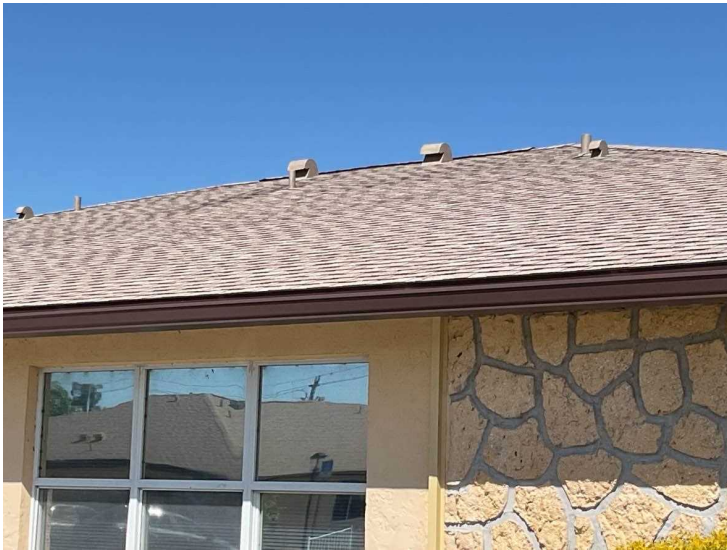
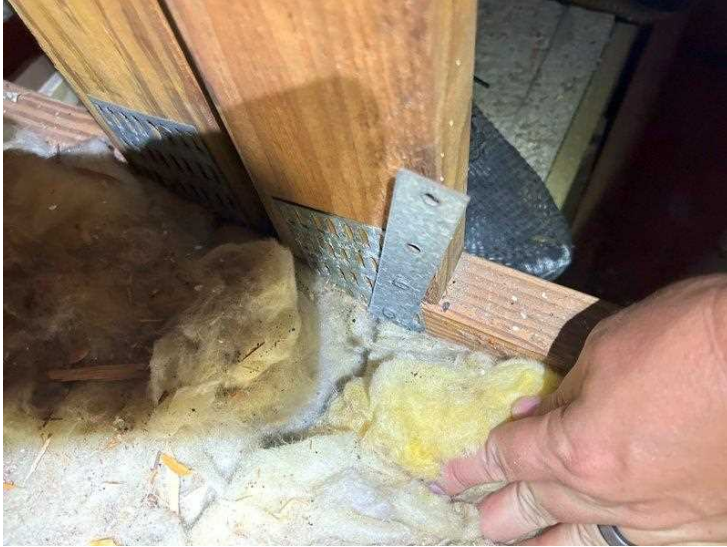
Roof Construction

- 3. Roof Deck Attachment:** **Level C**
Comments: Inspection verified 1/2" plywood roof deck attached with 8d nails at a minimum 6" on the edge & 6" in the field.

- 6. SWR:** **Yes**
Comments: SWR was verified at time of inspection. The Secondary Water Resistance verified is a self-adhering peel and stick.
- 7. Opening Protection:** **None or Some Glazed Openings**
Comments: No opening protection verified at the time of inspection.
