Windstorm Mitigation Report (OIR-B1-1802)

Sunshine Villas Homeowners Association, Inc.

Bldg N, 21150 Gertrude Ave, Units 1-6

As of 10/26/2023 | FPAT File# MIT2321009

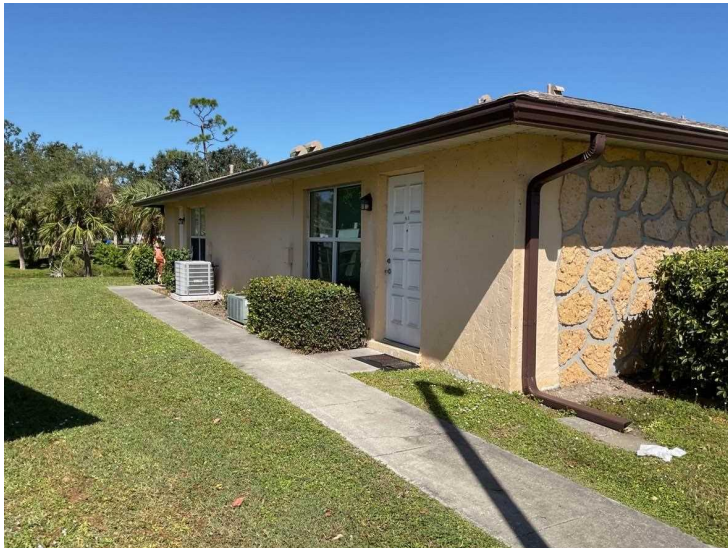
Exterior Elevation

- 4. Roof to Wall Attachment:** **Toe Nails**
Comments: Inspection verified embedded straps fastened with less than three nails.
- 5. Roof Geometry:** **Hip Roof**
Comments: Inspection verified a hip roof shape.

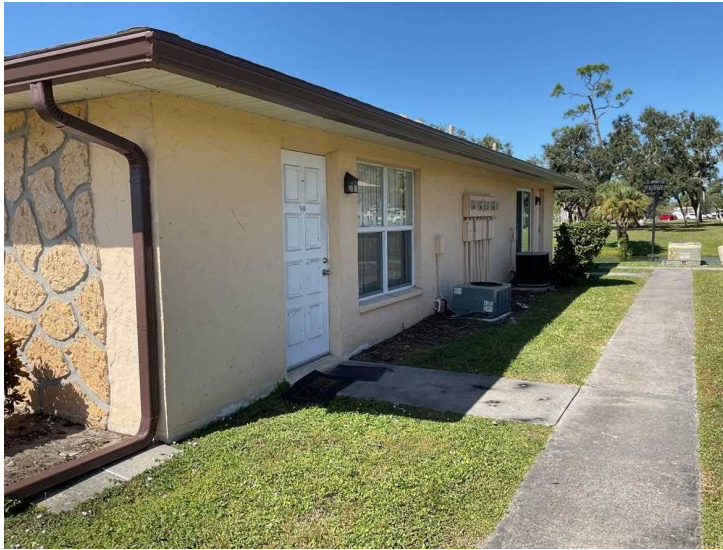
Roof Permit Information

Permit 20221259901:
Residential Roofing
Record Status: Closed

Job Description:
BLDG N: Remove existing roof, re-nail deck as per FBC and install self-adhering Resisto underlayment, install new shingle.

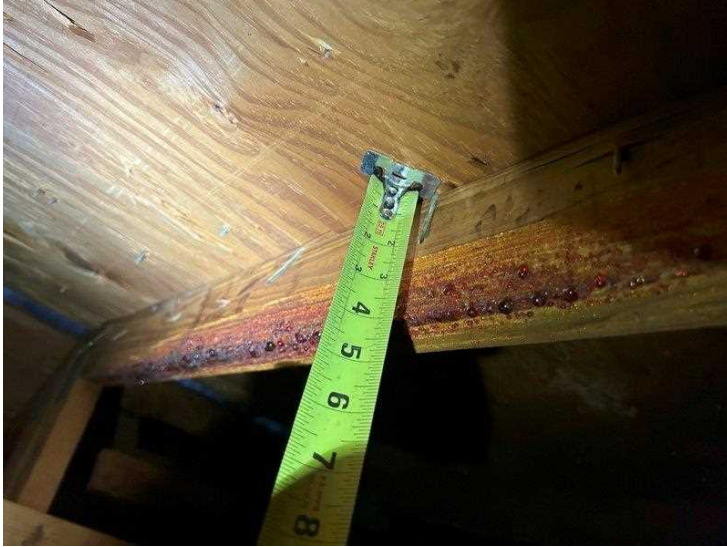
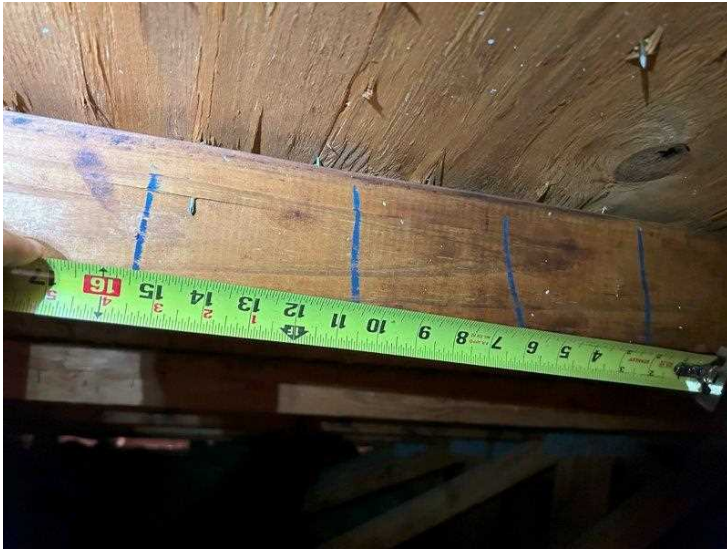
Roof Construction

- 3. Roof Deck Attachment:** **Level C**
Comments: Inspection verified 1/2" plywood roof deck attached with 8d nails at a minimum 6" on the edge & 6" in the field.

- 6. SWR:** **Yes**
Comments: SWR was verified at time of inspection. The Secondary Water Resistance verified is a self-adhering peel and stick.
- 7. Opening Protection:** **None or Some Glazed Openings**
Comments: No opening protection verified at the time of inspection.
