Windstorm Mitigation Report (OIR-B1-1802)

Sunshine Villas Homeowners Association, Inc.

Bldg E, 21150 Gertrude Ave, Units 1-4

As of 10/26/2023 | FPAT File# MIT2321009

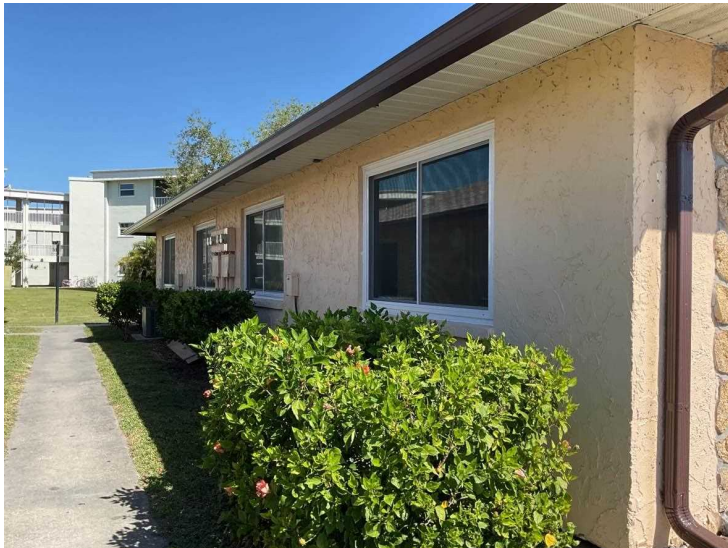
Exterior Elevation

- 4. Roof to Wall Attachment:** **Toe Nails**
Comments: Inspection verified embedded straps fastened with less than three nails.
- 5. Roof Geometry:** **Hip Roof**
Comments: Inspection verified a hip roof shape.

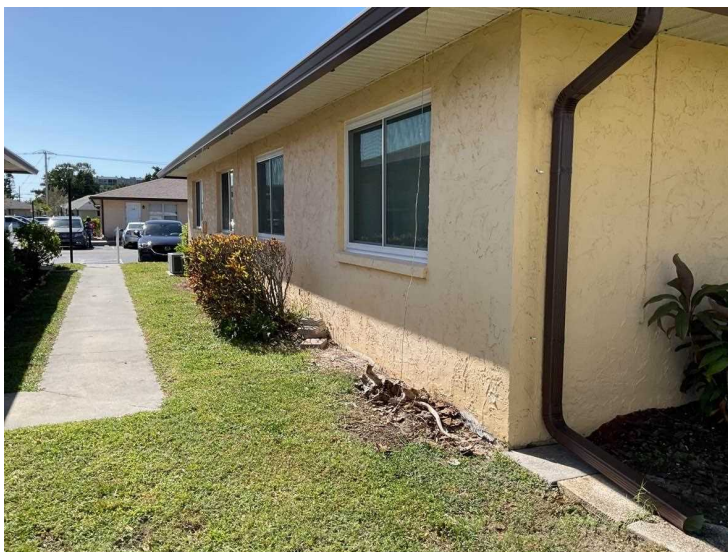
Exterior Elevation

- 6. SWR:** **Yes**
Comments: SWR was verified at time of inspection. The Secondary Water Resistance verified is a self-adhering peel and stick.
- 7. Opening Protection:** **None or Some Glazed Openings**
Comments: No opening protection verified at the time of inspection.

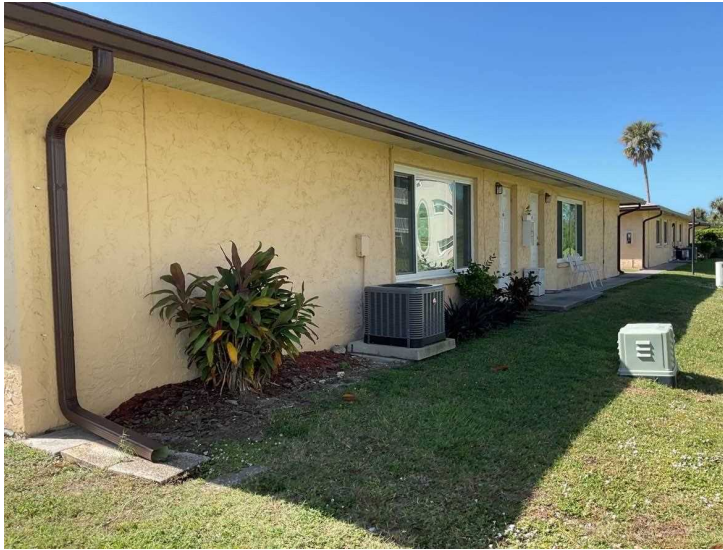
Roof Permit Information

Permit 20221259654:
Residential Roofing
Record Status: Closed

Job Description:
BLDG E: Remove existing roof, re-nail deck as per FBC and install self-adhering Resisto underlayment, install new shingle.

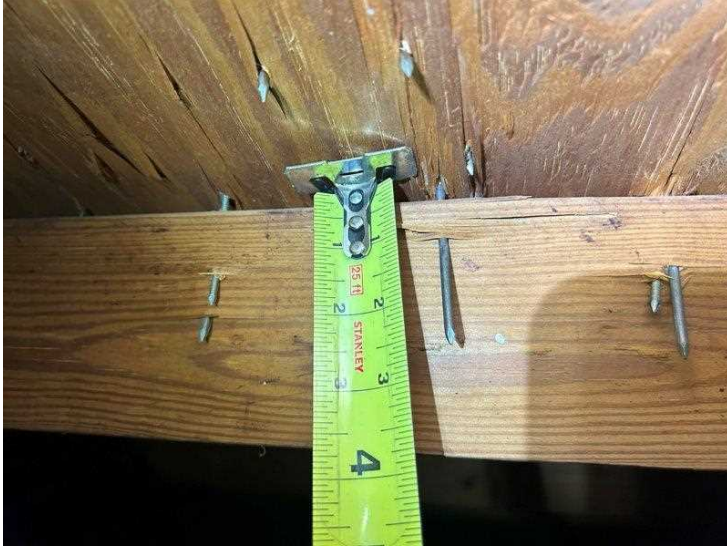
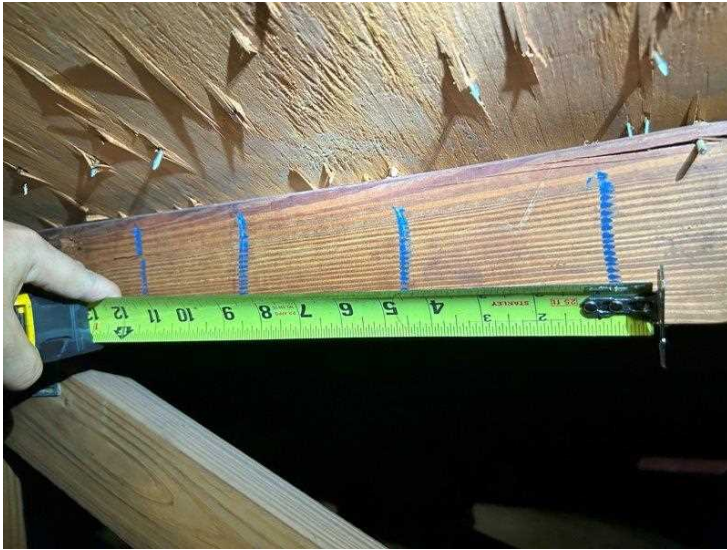
Roof Construction

- 3. Roof Deck Attachment:** **Level C**
Comments: Inspection verified 1/2" plywood roof deck attached with 8d nails at a minimum 6" on the edge & 6" in the field.
