## Windstorm Mitigation Report (OIR-B1-1802)

Sunshine Villas Homeowners Association, Inc.

Bldg R, 21150 Gertrude Ave, Units 1-6

As of 10/26/2023 | FPAT File# MIT2321009

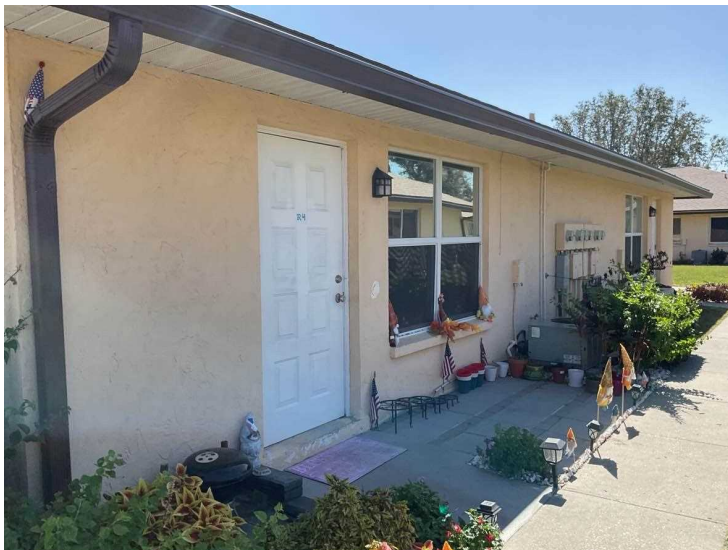
Exterior Elevation

- 4. Roof to Wall Attachment:** **Toe Nails**  
Comments: Inspection verified embedded straps fastened with less than three nails.
- 5. Roof Geometry:** **Hip Roof**  
Comments: Inspection verified a hip roof shape.

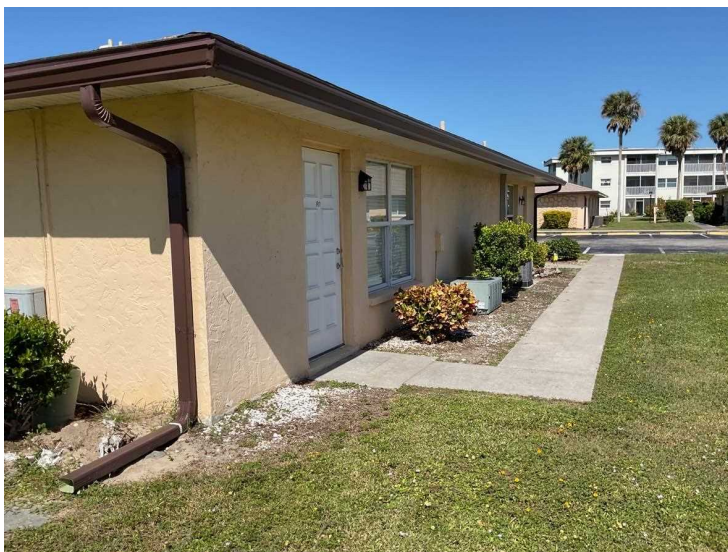
Exterior Elevation

- 6. SWR:** **Yes**  
Comments: SWR was verified at time of inspection. The Secondary Water Resistance verified is a self-adhering peel and stick.
- 7. Opening Protection:** **None or Some Glazed Openings**  
Comments: No opening protection verified at the time of inspection.

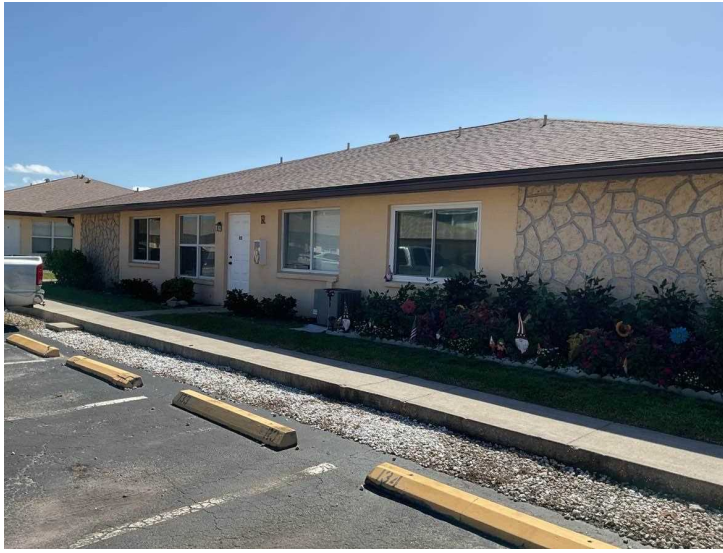
Roof Permit  
Information

- 2. Roof Covering:** **FBC Equivalent**  
Comments: The roof covering was replaced in 2022. The roof permit was confirmed and the permit number is 20221259957. This roof was verified as meeting the building code requirements outlined on the mitigation affidavit.

**Job Description:**  
BLDG R: Remove existing roof, re-nail deck as per FBC and install self-adhering Resisto underlayment, install new shingle.

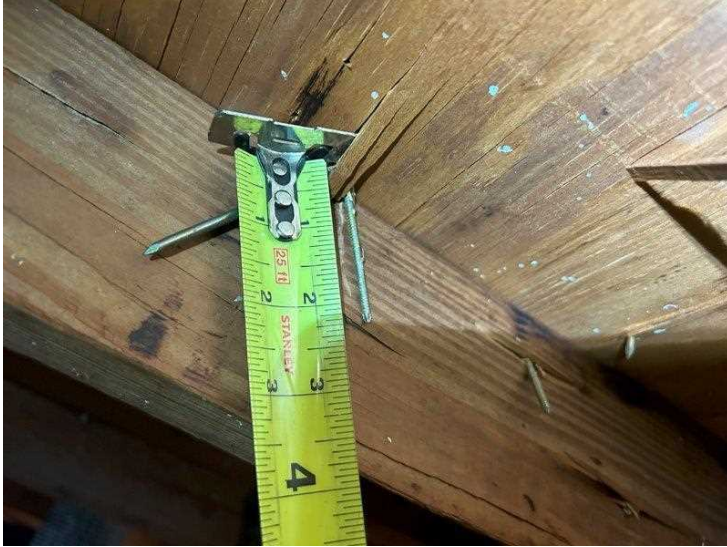
Roof Construction

- 3. Roof Deck Attachment:** **Level C**  
Comments: Inspection verified 1/2" plywood roof deck attached with 8d nails at a minimum 6" on the edge & 6" in the field.
