Windstorm Mitigation Report (OIR-B1-1802)

Sunshine Villas Homeowners Association, Inc.

Bldg L, 21150 Gertrude Ave, Units 1-4

As of 10/26/2023 | FPAT File# MIT2321009

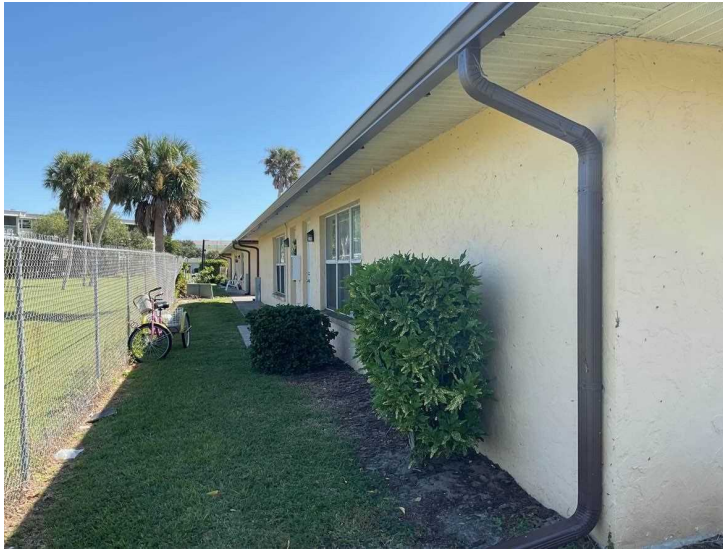
Roof Permit Information

Permit 20221259887:
Residential Roofing
Record Status: Closed

Job Description:
BLDG L: Remove existing roof, re-nail deck as per FBC and install self-adhering Resisto underlayment, install new shingle.

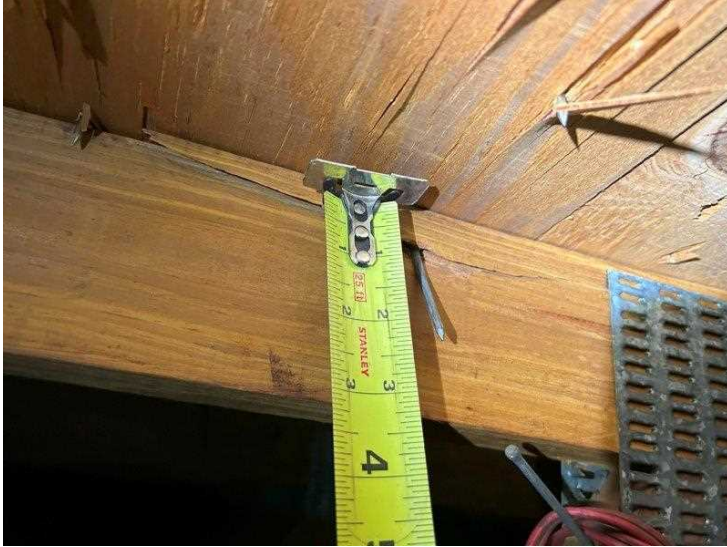
Roof Construction

- 3. Roof Deck Attachment:** **Level C**
Comments: Inspection verified 1/2" plywood roof deck attached with 8d nails at a minimum 6" on the edge & 6" in the field.

- 4. Roof to Wall Attachment:** **Toe Nails**
Comments: Inspection verified embedded straps fastened with less than three nails.
- 5. Roof Geometry:** **Hip Roof**
Comments: Inspection verified a hip roof shape.

- 6. SWR:** **Yes**
Comments: SWR was verified at time of inspection. The Secondary Water Resistance verified is a self-adhering peel and stick.
- 7. Opening Protection:** **None or Some Glazed Openings**
Comments: No opening protection verified at the time of inspection.
