Windstorm Mitigation Report (OIR-B1-1802)

Sunshine Villas Homeowners Association, Inc.

Bldg S, 21150 Gertrude Ave, Units 1-6

As of 10/26/2023 | FPAT File# MIT2321009

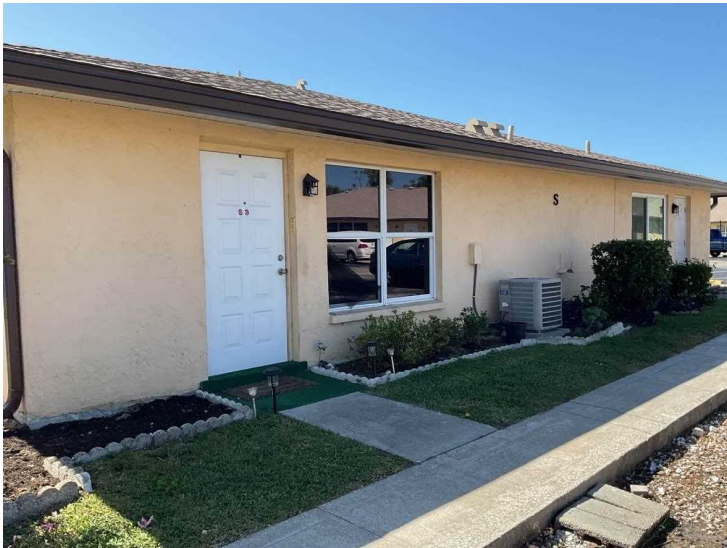
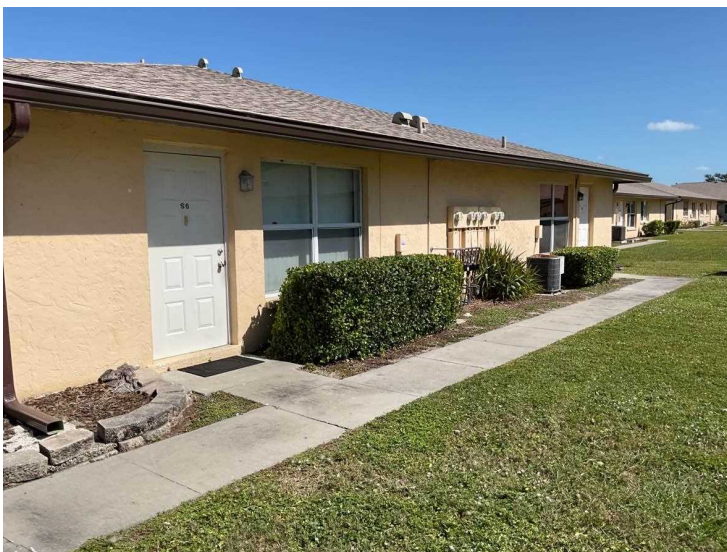
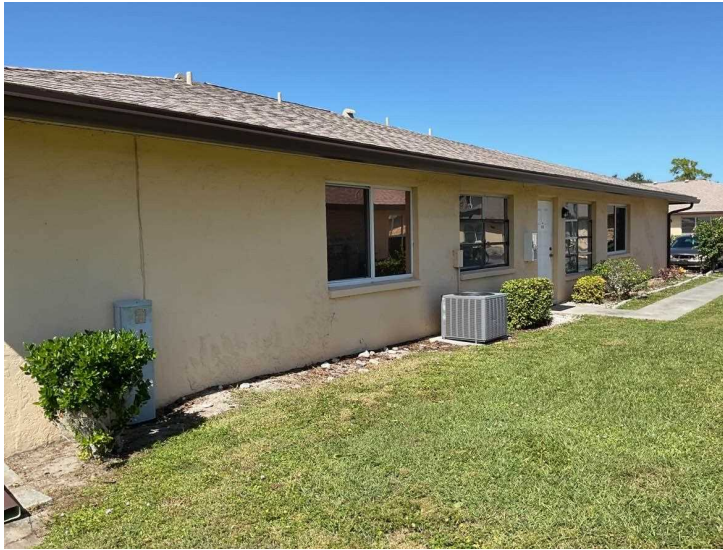
Exterior Elevation

- 4. Roof to Wall Attachment:** **Toe Nails**
Comments: Inspection verified embedded straps fastened with less than three nails.
- 5. Roof Geometry:** **Hip Roof**
Comments: Inspection verified a hip roof shape.

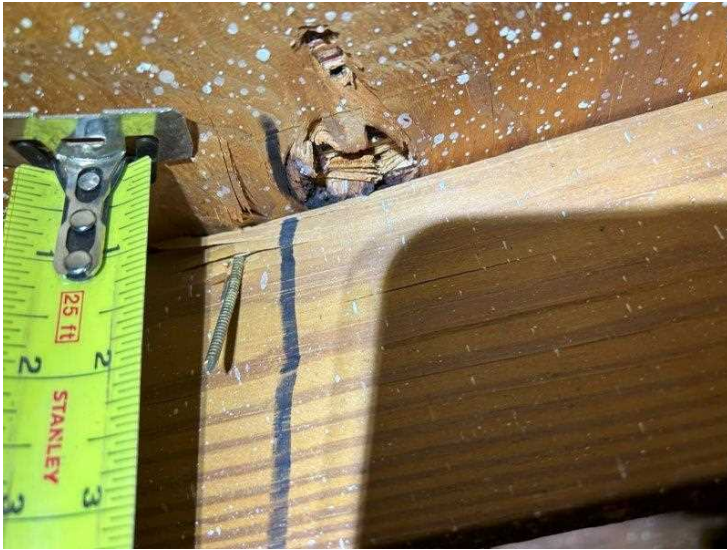
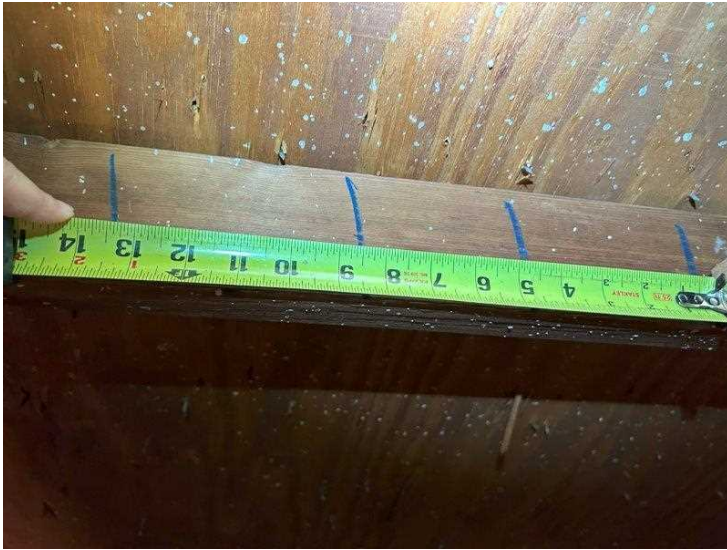
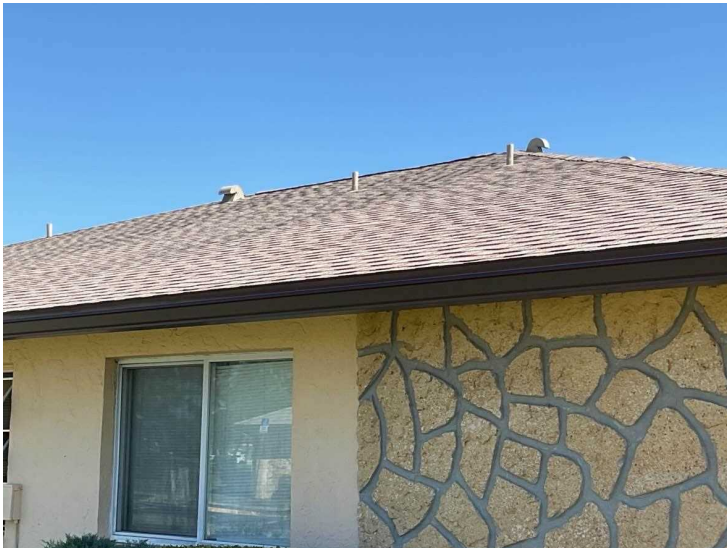
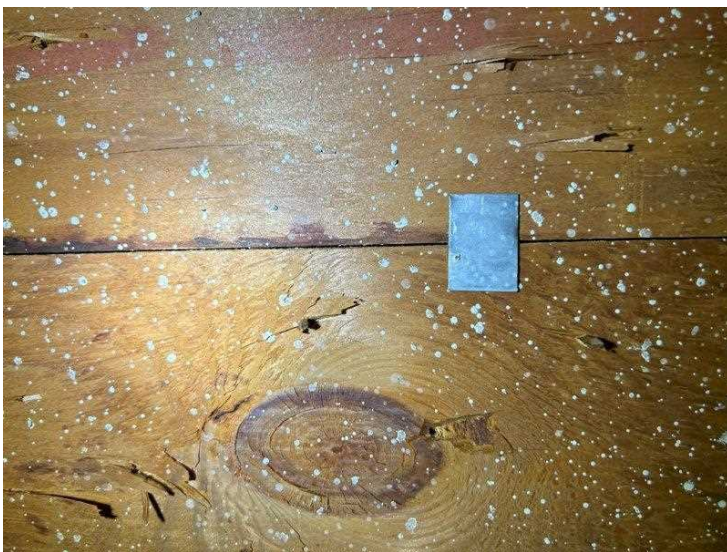
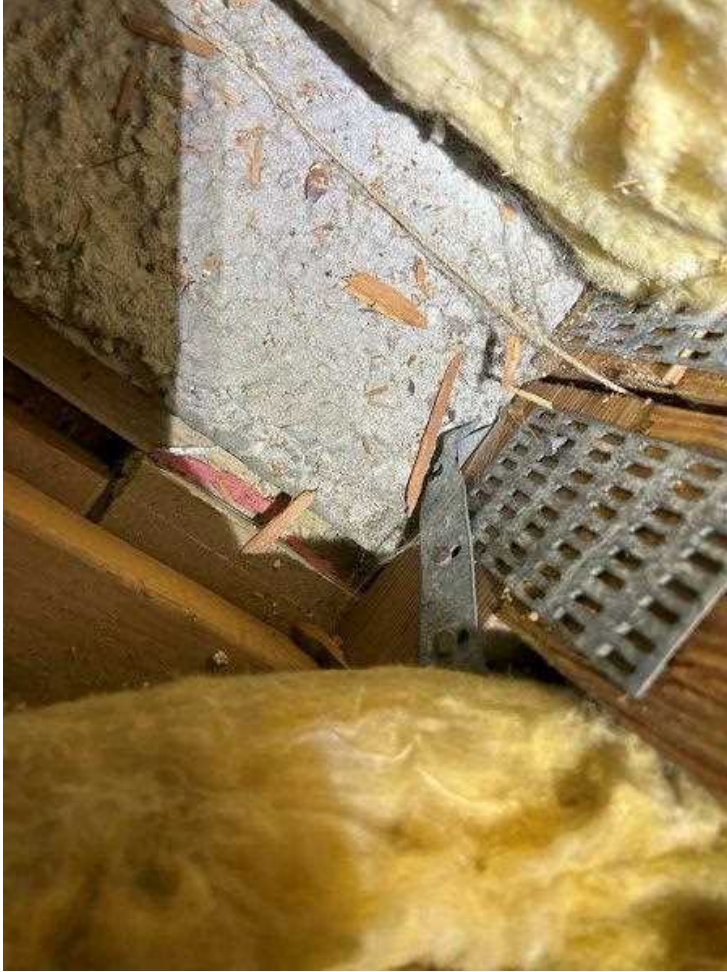
Roof Construction

- 3. Roof Deck Attachment:** **Level C**
Comments: Inspection verified 1/2" plywood roof deck attached with 8d nails at a minimum 6" on the edge & 6" in the field.

- 6. SWR:** **Yes**
Comments: SWR was verified at time of inspection. The Secondary Water Resistance verified is a self-adhering peel and stick.
- 7. Opening Protection:** **None or Some Glazed Openings**
Comments: No opening protection verified at the time of inspection.

Job Description:
BLDG S: Remove existing roof, re-nail deck as per FBC and install self-adhering Resisto underlayment, install new shingle.
