Windstorm Mitigation Report (OIR-B1-1802)

Sunshine Villas Homeowners Association, Inc.

Bldg C, 21150 Gertrude Ave, Units 1-6

As of 10/26/2023 | FPAT File# MIT2321009

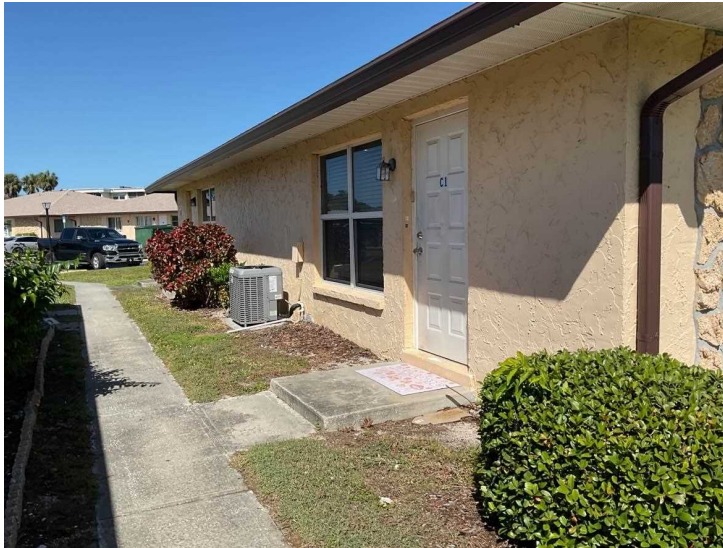
Roof Permit Information

Permit 20221259262:
Residential Roofing
Record Status: Closed

Job Description:
Bldg C: Remove existing roof, re-nail deck as per FBC and install self-adhering Resisto underlayment, install new shingle.

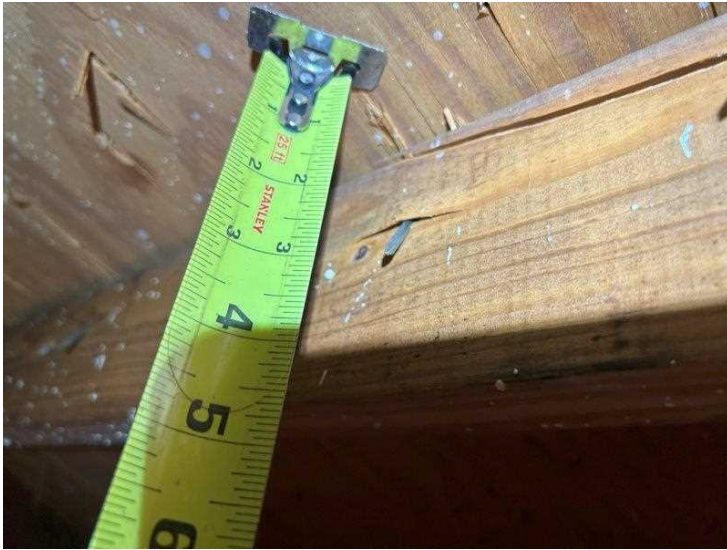
Roof Construction

- 3. Roof Deck Attachment:** **Level C**
Comments: Inspection verified 1/2" plywood roof deck attached with 8d nails at a minimum 6" on the edge & 6" in the field.

- 4. Roof to Wall Attachment:** **Toe Nails**
Comments: Inspection verified embedded straps fastened with less than three nails.
- 5. Roof Geometry:** **Hip Roof**
Comments: Inspection verified a hip roof shape.

- 6. SWR:** **Yes**
Comments: SWR was verified at time of inspection. The Secondary Water Resistance verified is a self-adhering peel and stick.
- 7. Opening Protection:** **None or Some Glazed Openings**
Comments: No opening protection verified at the time of inspection.
