## Windstorm Mitigation Report (OIR-B1-1802)

Sunshine Villas Homeowners Association, Inc.

Bldg B, 21150 Gertrude Ave, Units 1-6

As of 10/26/2023 | FPAT File# MIT2321009

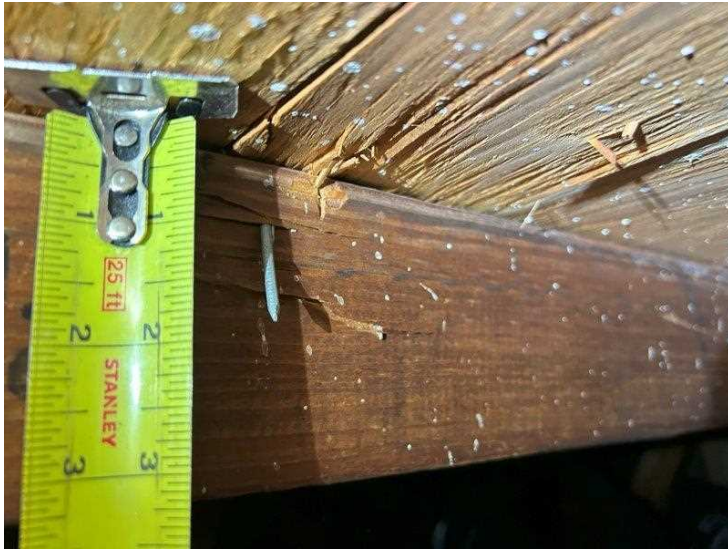
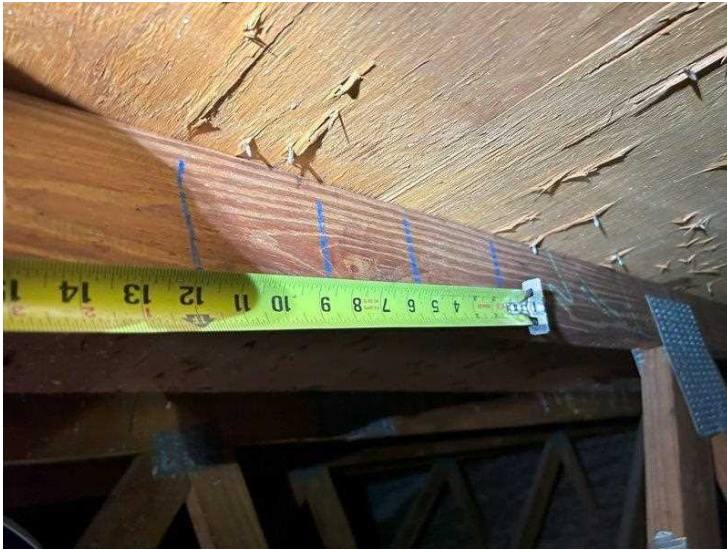
Roof Construction

- 3. Roof Deck Attachment:** **Level C**  
Comments: Inspection verified 1/2" plywood roof deck attached with 8d nails at a minimum 6" on the edge & 6" in the field.

- 4. Roof to Wall Attachment:** **Toe Nails**  
Comments: Inspection verified embedded straps fastened with less than three nails.
- 5. Roof Geometry:** **Hip Roof**  
Comments: Inspection verified a hip roof shape.

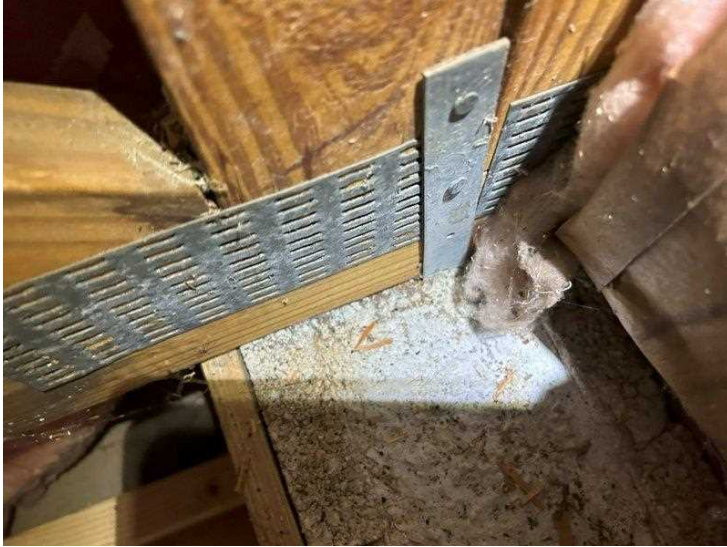
Roof Construction

- 6. SWR:** **Yes**  
Comments: SWR was verified at time of inspection. The Secondary Water Resistance verified is a self-adhering peel and stick.
- 7. Opening Protection:** **None or Some Glazed Openings**  
Comments: No opening protection verified at the time of inspection.
