Windstorm Mitigation Report (OIR-B1-1802)

Sunshine Villas Homeowners Association, Inc.

Bldg A, 21150 Gertrude Ave, Units 1-4

As of 10/26/2023 | FPAT File# MIT2321009

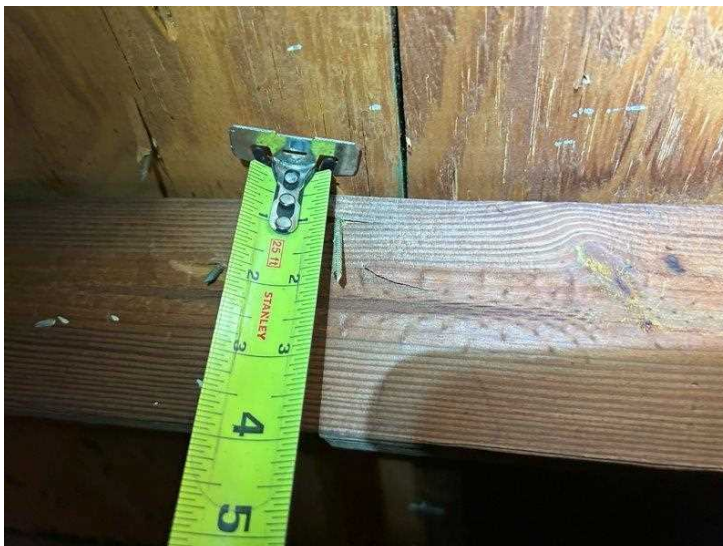
Roof Construction

- 3. Roof Deck Attachment:** **Level C**
Comments: Inspection verified 1/2" plywood roof deck attached with 8d nails at a minimum 6" on the edge & 6" in the field.

- 4. Roof to Wall Attachment:** **Toe Nails**
Comments: Inspection verified embedded straps fastened with less than three nails.
- 5. Roof Geometry:** **Hip Roof**
Comments: Inspection verified a hip roof shape.

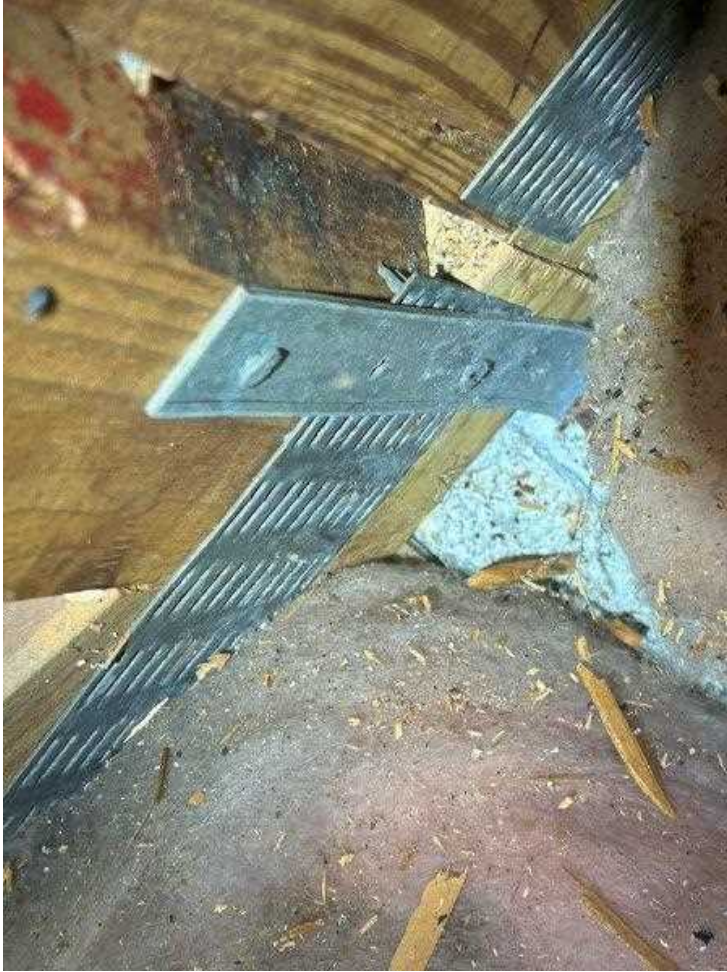
Roof Construction

- 6. SWR:** **Yes**
Comments: SWR was verified at time of inspection. The Secondary Water Resistance verified is a self-adhering peel and stick.
- 7. Opening Protection:** **None or Some Glazed Openings**
Comments: No opening protection verified at the time of inspection.
