Windstorm Mitigation Report (OIR-B1-1802)

Sunshine Villas Homeowners Association, Inc.

Bldg T, 21150 Gertrude Ave, Units 1-6

As of 10/26/2023 | FPAT File# MIT2321009

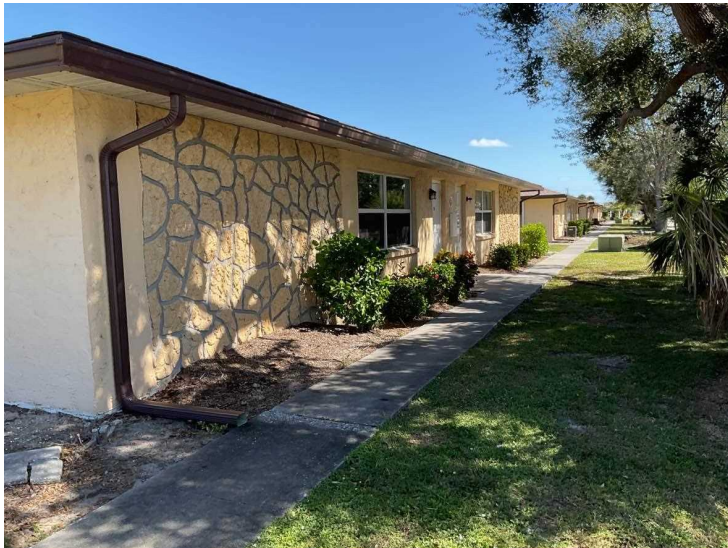
Exterior Elevation

- 4. Roof to Wall Attachment:** **Toe Nails**
Comments: Inspection verified embedded straps fastened with less than three nails.
- 5. Roof Geometry:** **Hip Roof**
Comments: Inspection verified a hip roof shape.

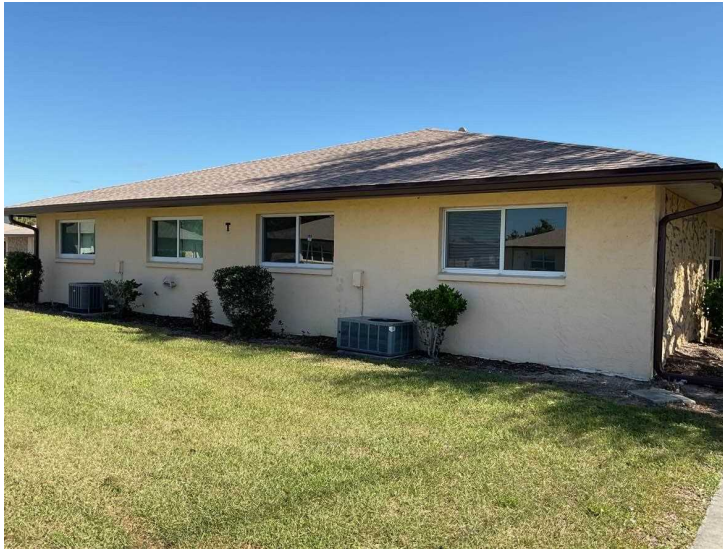
Roof Permit Information

- 2. Roof Covering:** **FBC Equivalent**
Comments: The roof covering was replaced in 2022. The roof permit was confirmed and the permit number is 20221259970. This roof was verified as meeting the building code requirements outlined on the mitigation affidavit.

Permit 20221259970:
Residential Roofing
Record Status: **Closed**

Job Description: BLDG T: Remove existing roof, re-nail deck as per FBC and install self-adhering Resisto underlayment, install new shingle.	Owner: SUNSHINE VILLAS HOMEOWNERS ASSOC INC * PO BOX 494016 PORT CHARLOTTE FL 33949
---	---

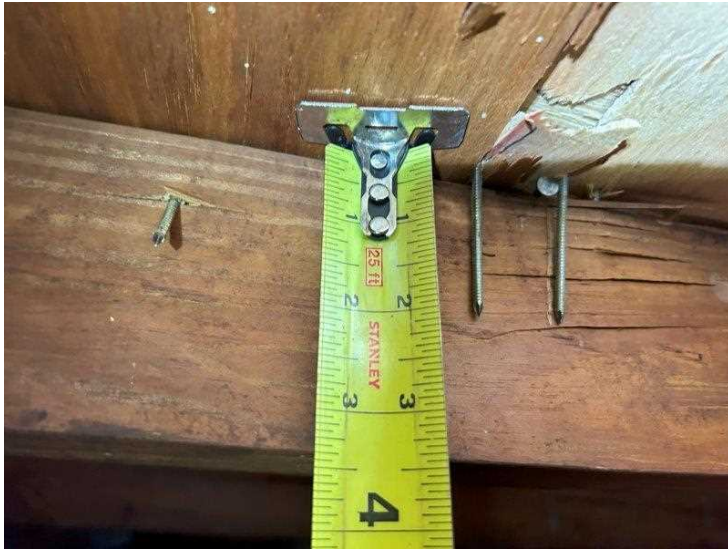
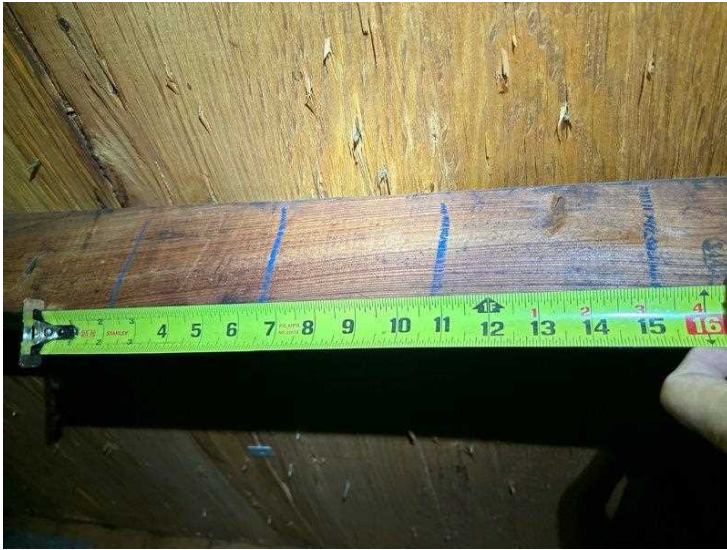
Roof Construction

- 3. Roof Deck Attachment:** **Level C**
Comments: Inspection verified 1/2" plywood roof deck attached with 8d nails at a minimum 6" on the edge & 6" in the field.

- 6. SWR:** **Yes**
Comments: SWR was verified at time of inspection. The Secondary Water Resistance verified is a self-adhering peel and stick.
- 7. Opening Protection:** **None or Some Glazed Openings**
Comments: No opening protection verified at the time of inspection.
