Windstorm Mitigation Report (OIR-B1-1802)

Sunshine Villas Homeowners Association, Inc.

Bldg I, 21150 Gertrude Ave, Units 1-6

As of 10/26/2023 | FPAT File# MIT2321009

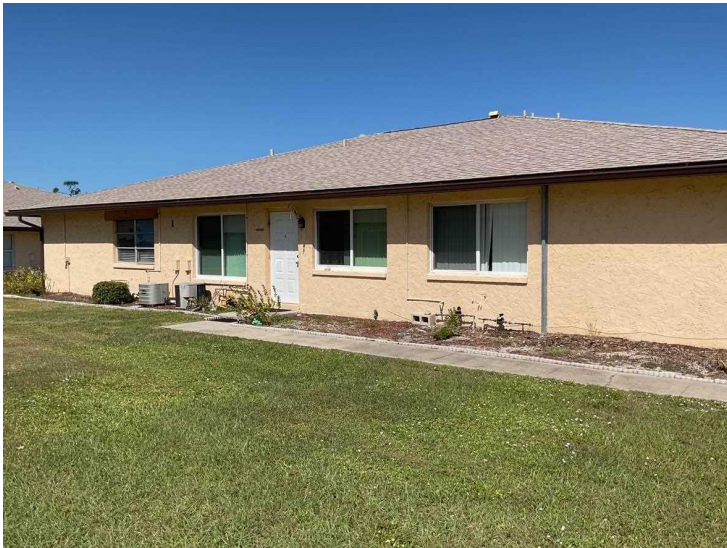
Exterior Elevation

- 4. Roof to Wall Attachment:** **Toe Nails**
Comments: Inspection verified embedded straps fastened with less than three nails.
- 5. Roof Geometry:** **Hip Roof**
Comments: Inspection verified a hip roof shape.

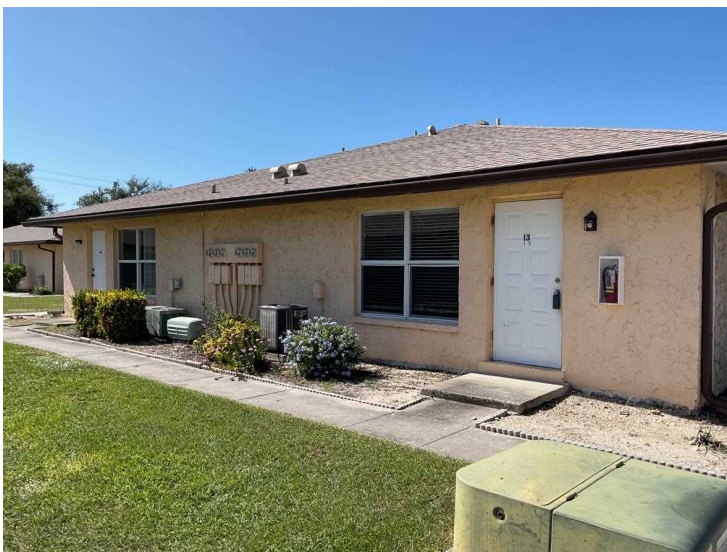
Exterior Elevation

- 6. SWR:** **Yes**
Comments: SWR was verified at time of inspection. The Secondary Water Resistance verified is a self-adhering peel and stick.
- 7. Opening Protection:** **None or Some Glazed Openings**
Comments: No opening protection verified at the time of inspection.

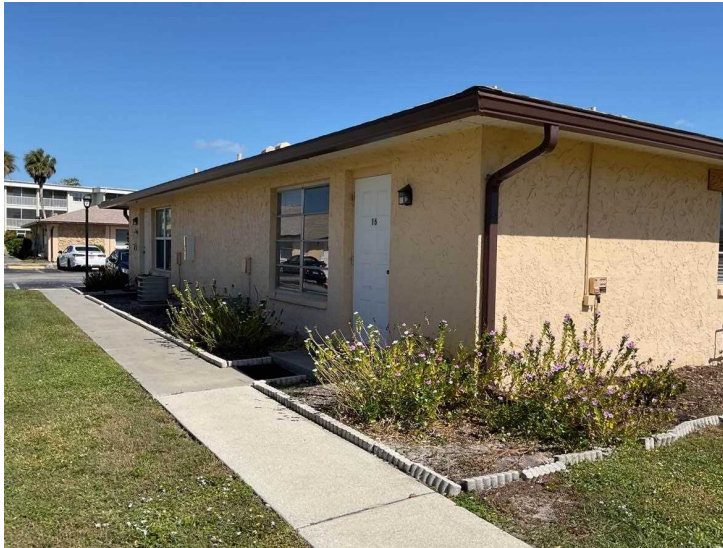
Roof Permit Information

- 2. Roof Covering:** **FBC Equivalent**
Comments: The roof covering was replaced in 2022. The roof permit was confirmed and the permit number is 20221259658. This roof was verified as meeting the building code requirements outlined on the mitigation affidavit.

Permit 20221259658:
Residential Roofing
Record Status: Closed

Job Description: BLDG I: Remove existing roof, re-nail deck as per FBC and install self-adhering Resisto underlayment, install new shingle.	Owner: SUNSHINE VILLAS HOMEOWNERS ASSOC INC * PO BOX 494016 PORT CHARLOTTE FL 33949
---	---

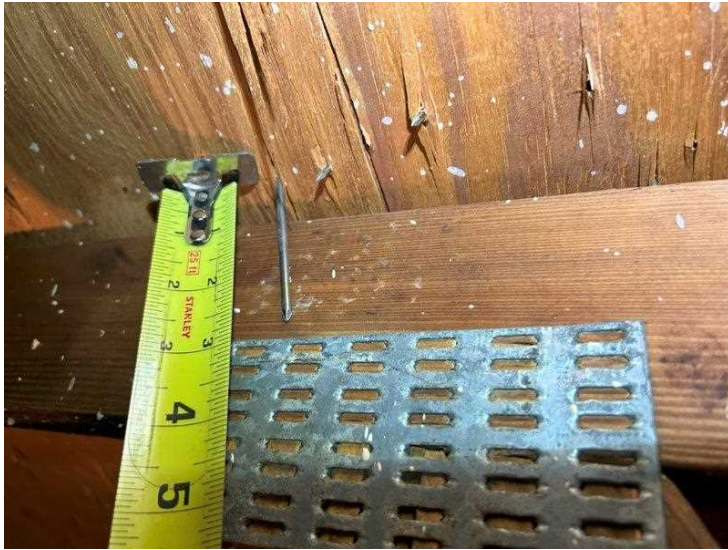
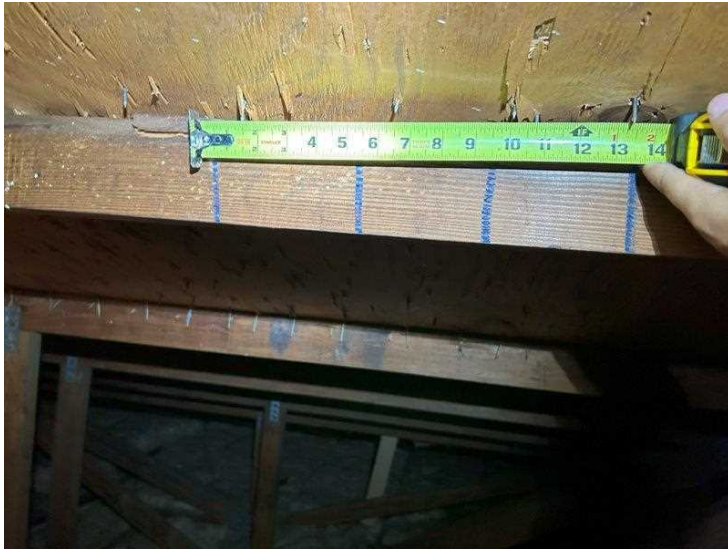
Roof Construction

- 3. Roof Deck Attachment:** **Level C**
Comments: Inspection verified 1/2" plywood roof deck attached with 8d nails at a minimum 6" on the edge & 6" in the field.
