Windstorm Mitigation Report (OIR-B1-1802)

Sunshine Villas Homeowners Association, Inc.

Bldg F, 21150 Gertrude Ave, Units 1-6

As of 10/26/2023 | FPAT File# MIT2321009

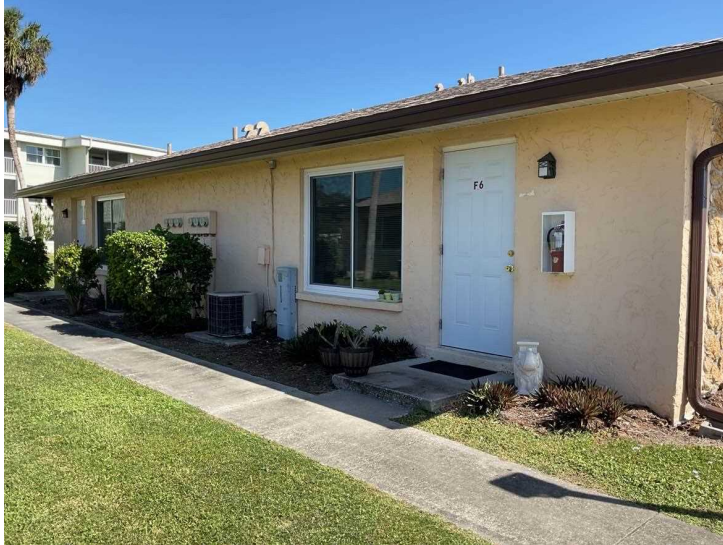
Permit 20221259655:
Residential Roofing
Record Status: Closed

Job Description:
BLDG F: Remove existing roof, re-nail deck as per FBC and install self-adhering Resisto underlayment, install new shingle.

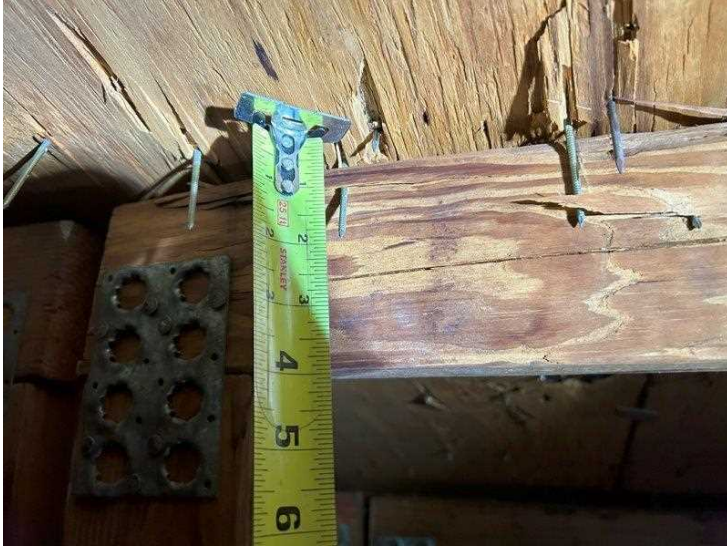
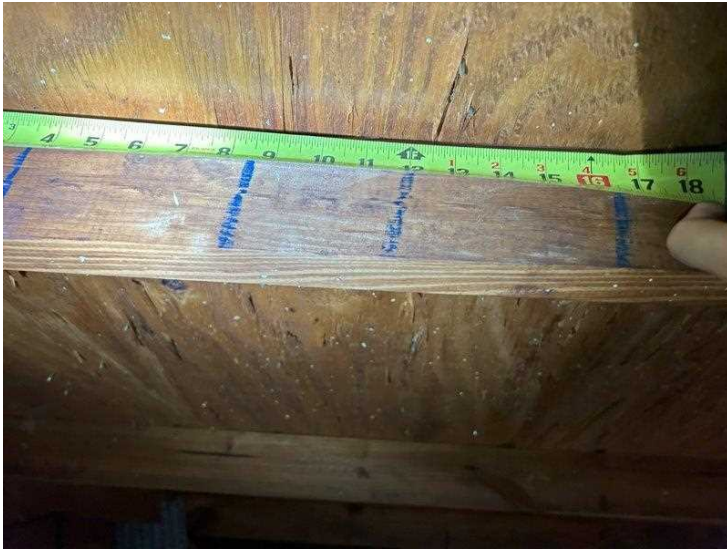
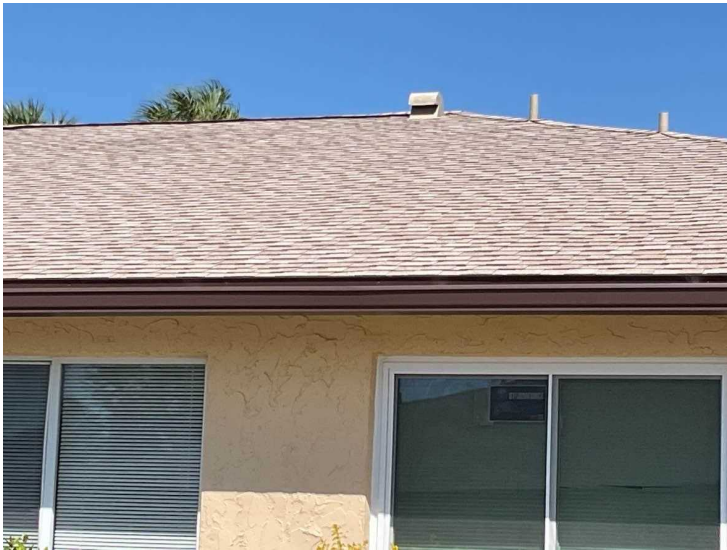
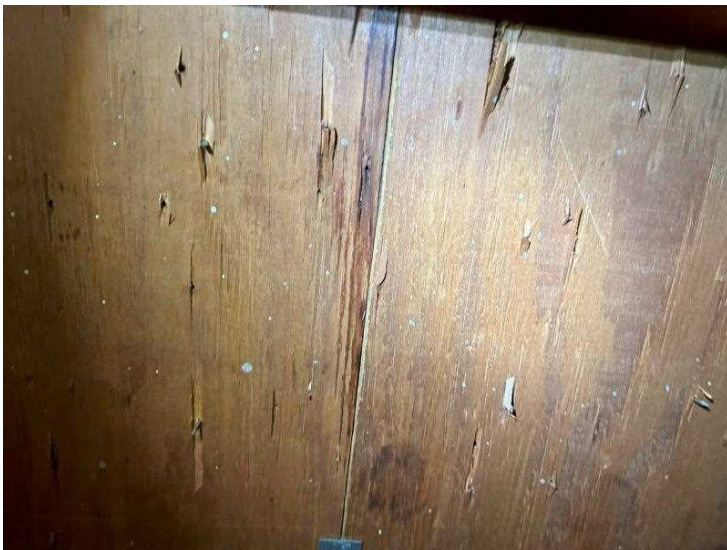
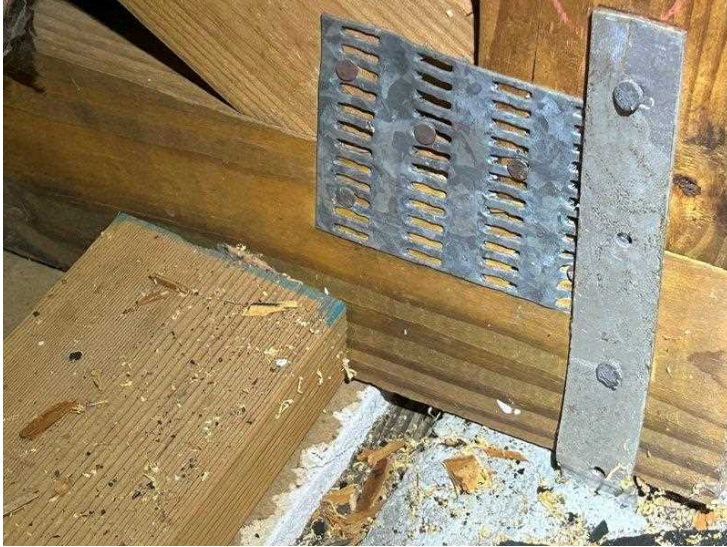
Roof Construction

- 3. Roof Deck Attachment:** **Level C**
Comments: Inspection verified 1/2" plywood roof deck attached with 8d nails at a minimum 6" on the edge & 6" in the field.

- 4. Roof to Wall Attachment:** **Toe Nails**
Comments: Inspection verified embedded straps fastened with less than three nails.
- 5. Roof Geometry:** **Hip Roof**
Comments: Inspection verified a hip roof shape.

- 6. SWR:** **Yes**
Comments: SWR was verified at time of inspection. The Secondary Water Resistance verified is a self-adhering peel and stick.
- 7. Opening Protection:** **None or Some Glazed Openings**
Comments: No opening protection verified at the time of inspection.
