Windstorm Mitigation Report (OIR-B1-1802)

Sunshine Villas Homeowners Association, Inc.

Bldg O, 21150 Gertrude Ave, Units 1-4

As of 10/26/2023 | FPAT File# MIT2321009

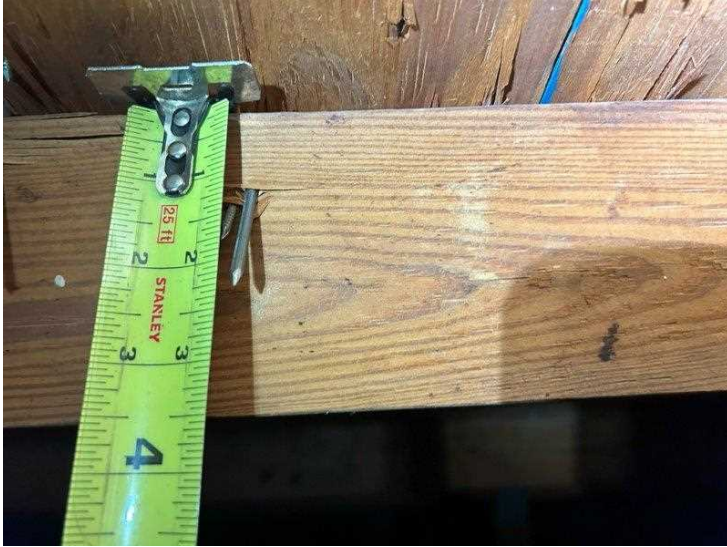
Roof Construction

- 3. Roof Deck Attachment:** **Level C**
Comments: Inspection verified 1/2" plywood roof deck attached with 8d nails at a minimum 6" on the edge & 6" in the field.

- 4. Roof to Wall Attachment:** **Toe Nails**
Comments: Inspection verified embedded straps fastened with less than three nails.
- 5. Roof Geometry:** **Hip Roof**
Comments: Inspection verified a hip roof shape.

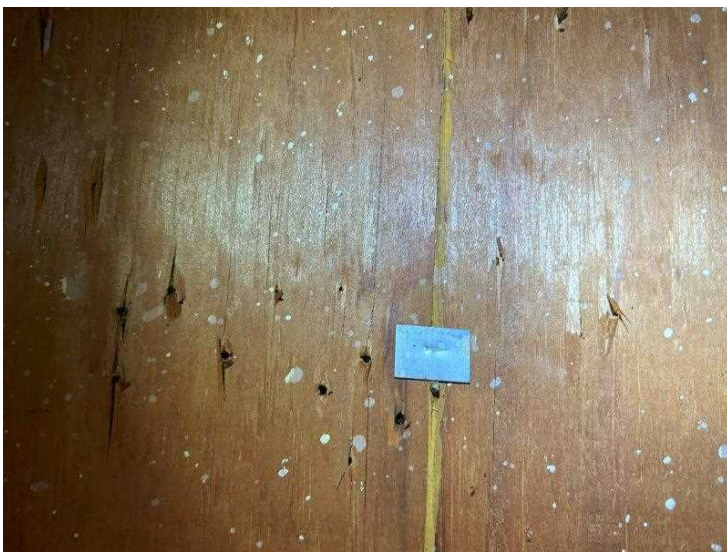
Roof Construction

- 6. SWR:** **Yes**
Comments: SWR was verified at time of inspection. The Secondary Water Resistance verified is a self-adhering peel and stick.
- 7. Opening Protection:** **None or Some Glazed Openings**
Comments: No opening protection verified at the time of inspection.
